Manhole Inspection Summary

Manhole # S17KK_006MH

Insp Date: **6/7/07 10:05 AM**

Location Address: **2051 WHEELER AVE**

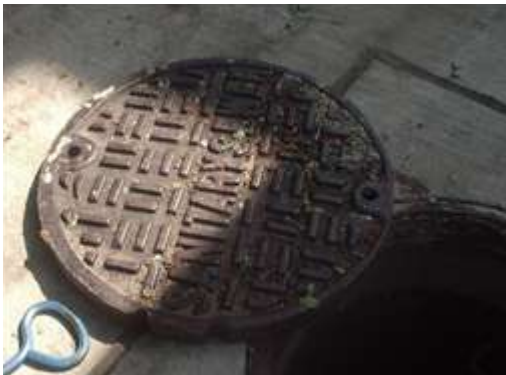
Defect 2

Type: **Sanitary** Condition: **Worn** Cover Material: **Cast Iron**

WORN COVER

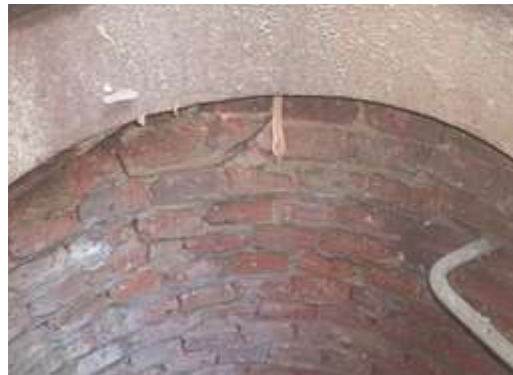
Defect 1

Condition: ☐ Sound ☒ **Cracked** ☐ Root Intrusion ☐ Loose Brick ☐ Deteriorated

CRACKED CORBEL

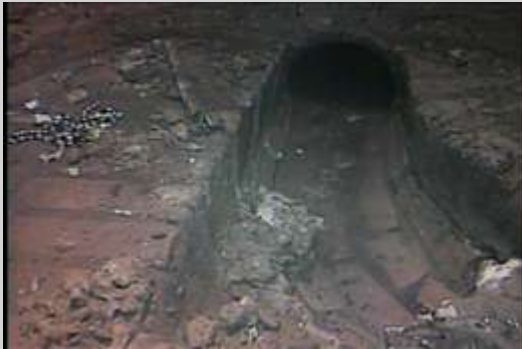
12 O'Clock Outflow

Pipe Height: **7.2** (in.) Rod and Bar (Angled)
Pipe Material: **Clay** ☐ Pipe Lined
Invert Depth: **6.70** (ft.) Flow Characteristics: **Slow**
Deposits: ☐ None ☐ Mud ☐ Sludge ☒ **Debris** ☐ Grease
Silt Depth: **2** (in.) Deposits Extent: **Light**
Infiltration: **None** Pipe Seal Cond: **Sound**

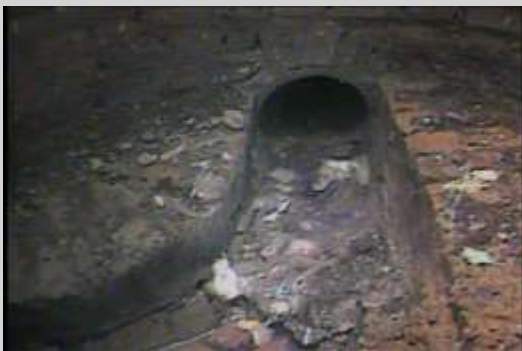
3 O'Clock Inflow

DEBRIS ON BENCH AND IN CHANNEL

Pipe Height: **8.4** (in.) Rod and Bar (Angled)
Pipe Material: **Clay** ☐ Pipe Lined
Invert Depth: **6.39** (ft.) Flow Characteristics: **Slow**
Deposits: ☐ None ☐ Mud ☐ Sludge ☒ **Debris** ☐ Grease
Silt Depth: **3** (in.) Deposits Extent: **Light**
Infiltration: **None** Pipe Seal Cond: **Sound**
